**Flood Control Project Maintenance
Levee Inspections**

Maintenance Issue Types Only, Levee Inspection Report By Mile - Fall 2015

Sacramento Maintenance Yard Sacramento Bypass

Waterway	Bank	Unit Miles	Inspection Start/End	Inspector
Unit No. 01 Sacramento Bypass or North Levee	Right	1.74	09/16/2015 09/16/2015	Jai Lor

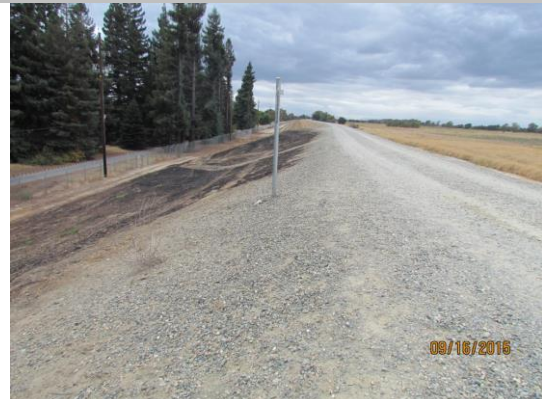
Photo 1 of 1 : FA_2015_ST0008_285_2_20150921_00003.jpg

LM Start	0.01	Rating **	A	Issue No.	2
LM End	1.78	Issue Type +	Ma	Location *	LS
Category	Earthen Levee			GPS Latitude/Longitude	
				Start	End
Item	Vegetation			38.602735 °	38.594626 °
				-121.555753 °	-121.586689 °
DWR ID	DWR_ST0008_02_f_2015_2				
Action/Comments					
Control annual grass and weeds on the levee slopes and easements. Inspector Comments: The slope has been burned and there is no obstruction to visibility.

View of the vegetation on the landward side of the levee looking downstream. Fall 2015.
